The 1st Symposium on Geotechnical engineering and the dams "problems and solutions", Iraqi

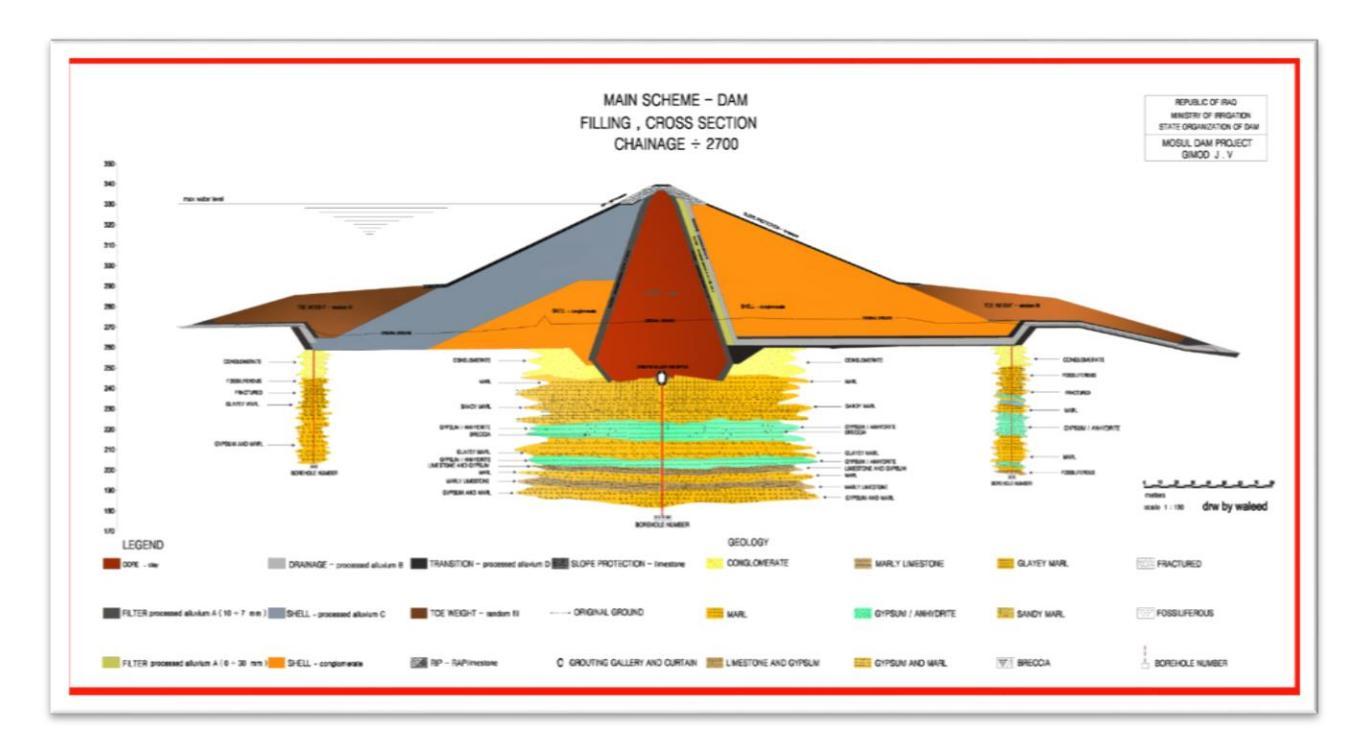
The Mosul dam was constructed on highly variable strata which consist of gypsum, anhydrite, marl, and limestone, each of which is soluble in water under the hydraulic conditions of the dam at a faster rate than natural geologic processes. The presence of such stratum in the foundation of hydraulic structure make the foundation is very poor and raises the worries about the stability of the dam concerning the safety and performance. Increasing the storage capacity of the dam will increase the weakness of the dam foundation resulted from the dissolution of gypsum, anhydrite, marl, and limestone. A mineralogic variability within rock units resulted from original depositional processes that created interfaces and zones of weakness within individual beds, the geological strata under the dam are shown in Figure 3.

Figure 3: Geological strata of Mosul dam

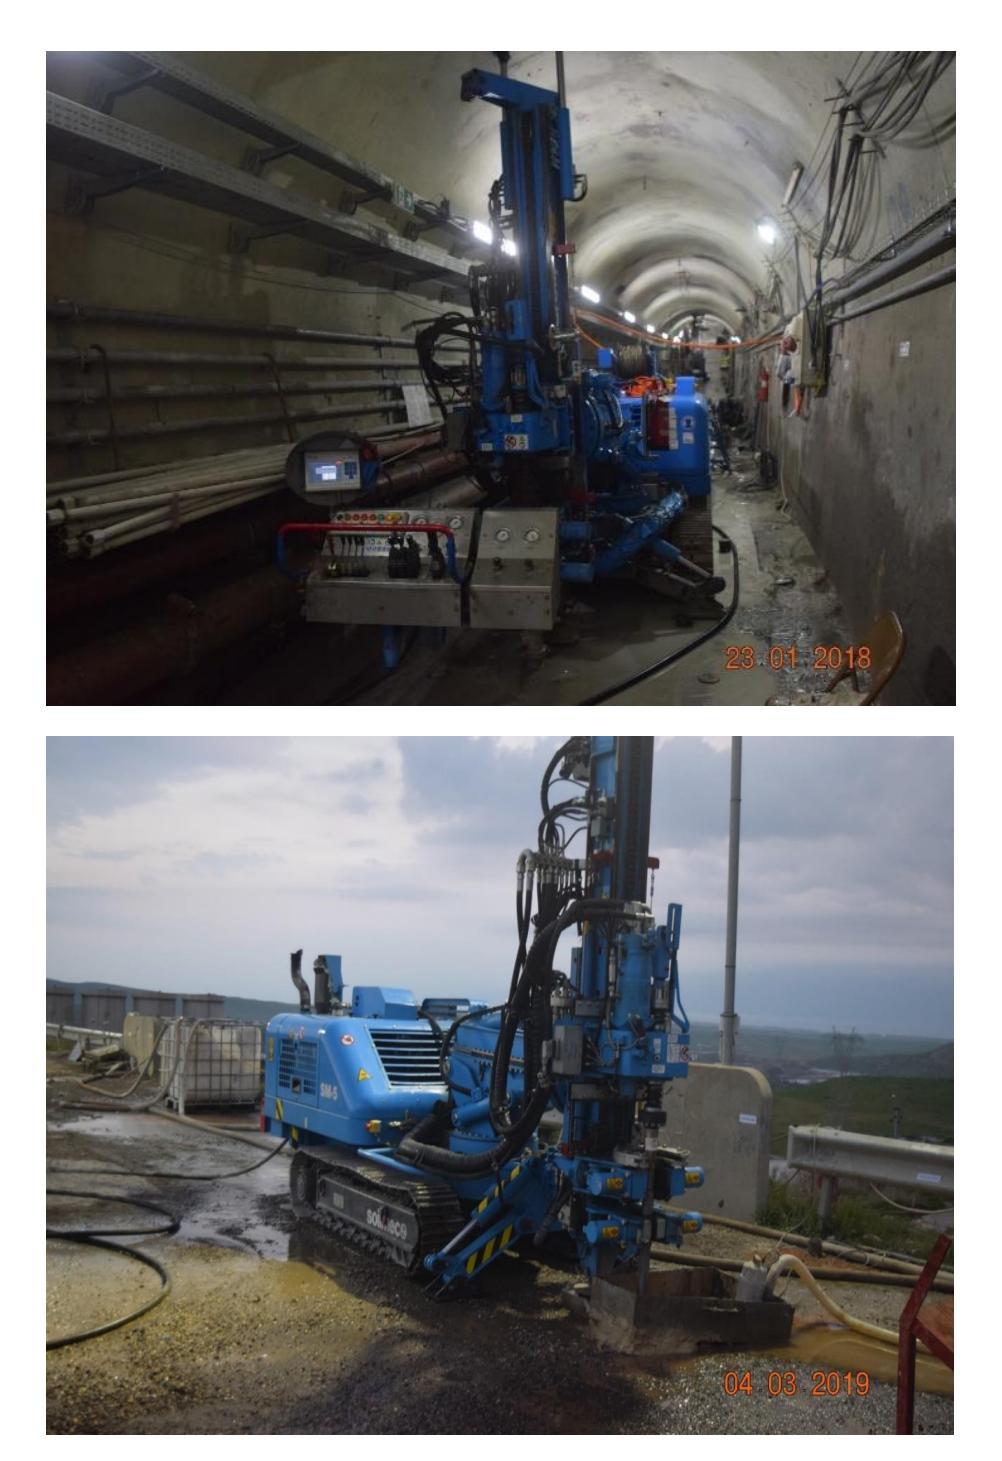
Figure 4: Drilling inside the tunnel and on the body of Mosul earth dam.

The problem of the dam foundation can be controlled with continuous grouting. The grouting process did not attract the attention of specialists and political decision makers after 2003 and especially during the year 2014 due to the security situations in Mosul, therefore, the problem of dissolution of gypsum rocks increased rapidly. After that, the effort of political Iraq government supported by the US Army Corps of Engineers focused on this problem in 2016 and awarded the work of evaluating the hydraulic situation and performance of the dam to an Italian company. This company started the work immediately by collecting geological and hydrological data and put a plan to continue the grouting process and monitoring the foundation of the dam by installing different types of instruments used to measure the hydraulic head, cavitation, rate of gypsum rocks dissolution and vertical settlement of the dam. Nowadays, there are more than 1500 instruments and sensors installed in different locations of the dam for monitoring the hydraulic and geological conditions of dam. The grouting process is continuous for 24 hrs./day, electrical rigs used in the tunnel inside the dam and diesel rigs are used in the open area as shown in Figure 4. A digital software is used to prepare the grouting mixture and injection process. Also, a photogrammetry technique is used to evaluate the efficiency of the grouting process. The grouting depth is increased from 100 m in 2000 to reach 150 m in 2019.
